# New Hampshire Volunteer Lake Assessment Program

## 2002 Bi-Annual Report for Crescent Lake Acworth

NHDES  
Water Division  
Watershed Management Bureau  
6 Hazen Drive

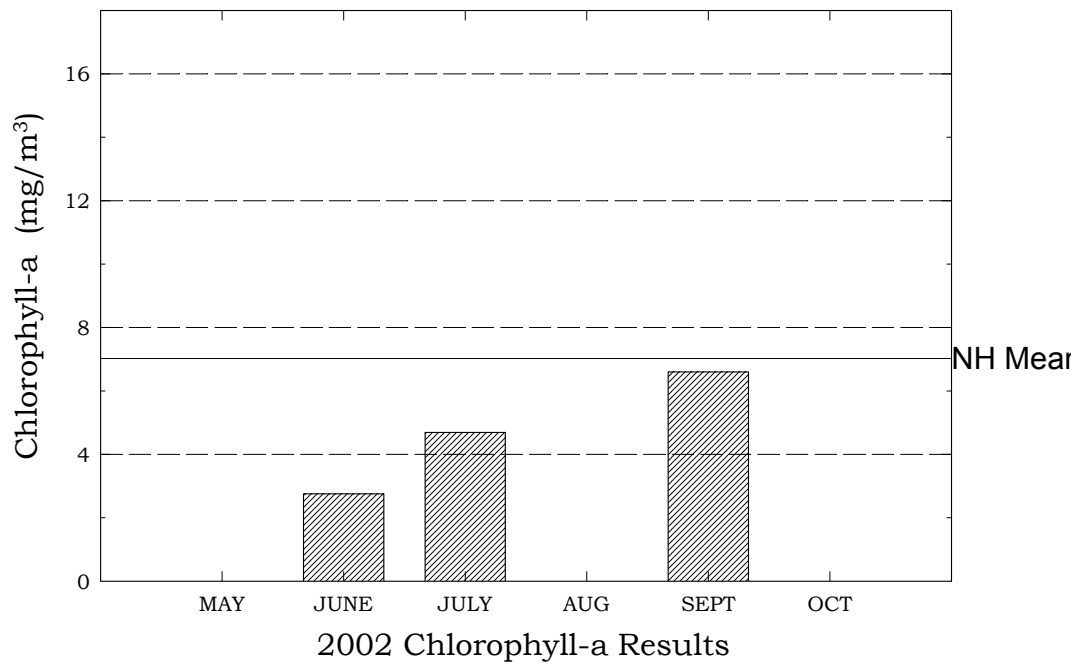
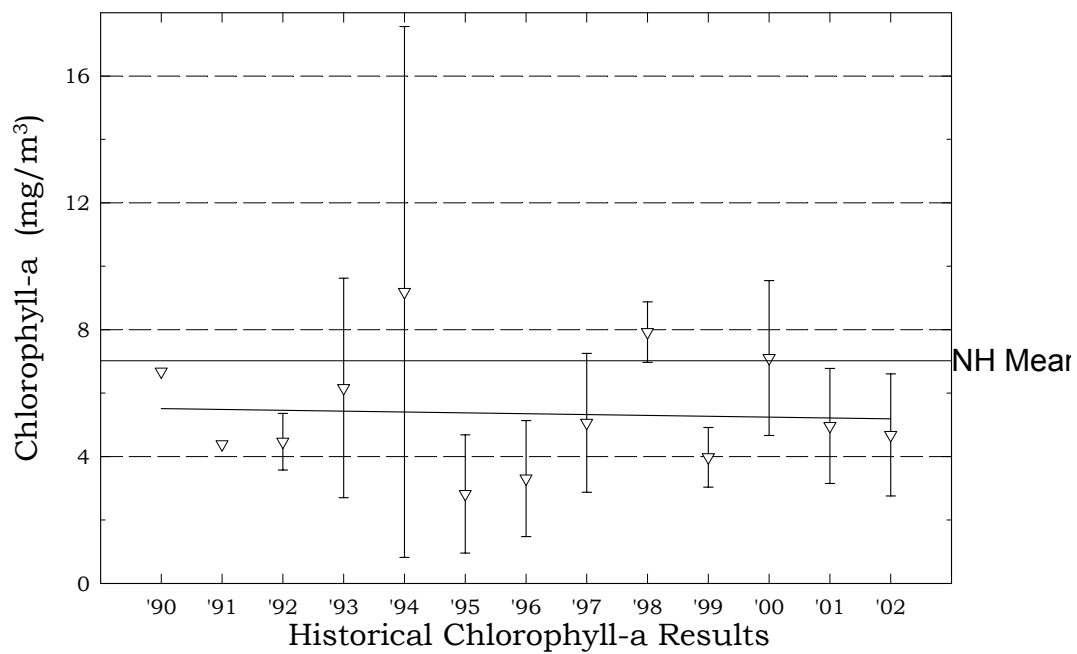
**Figure 1.** Monthly and Historical Chlorophyll-a Results

- **Figure 1 and Table 1:** The graphs in Figure 1 (Appendix A) show the historical and current year chlorophyll-a concentration in the water column. Table 1 (Appendix B) lists the maximum, minimum, and mean concentration for each sampling season that the lake/pond has been monitored through the program.

The current year data (the top graph) show that the chlorophyll-a concentration **increased** from June to July, and then **increased again** from July to September. The chlorophyll-a concentration in June and July was ***much less than*** the state mean, however, in September the concentration was only ***slightly less than*** the state mean.

The historical data (the bottom graph) show that the 2002 chlorophyll-a mean is **less than** state mean.

Overall, the statistical analysis of the historical data (the bottom graph) shows that the mean annual chlorophyll-a concentration has **not significantly changed** (either *increased* or *decreased*) since monitoring began in **1990**. Specifically, the chlorophyll-a concentration has **varied** (meaning **fluctuated**), but has not *continually increased* or *decreased* since monitoring began. (Note: Please refer to Appendix E for the detailed statistical analysis explanation and data print out.)

While algae is naturally present in all lakes/ponds, an excessive or increasing amount of any type is not welcomed. In freshwater lakes/ponds, phosphorus is the nutrient that algae depend upon for growth. Therefore, algal concentrations may increase when there is an increase in nonpoint sources of nutrient loading from the watershed, or in-lake sources of phosphorus loading (such as phosphorus releases from the sediments). It is important to continually educate residents about how activities within the watershed can affect phosphorus loading and lake quality.

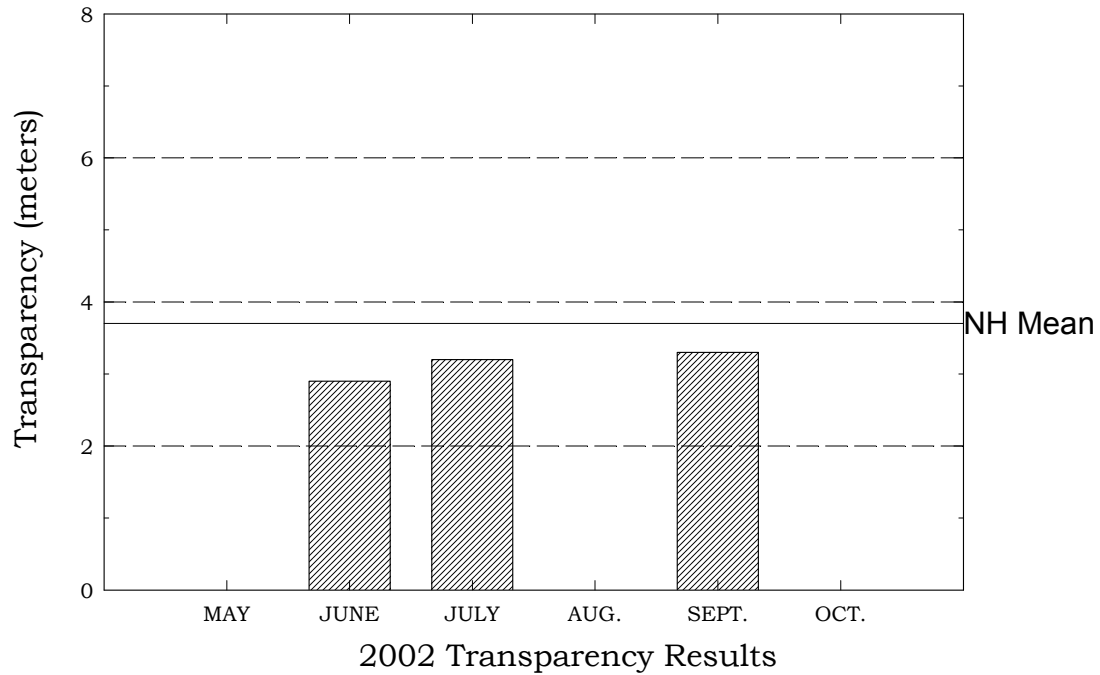
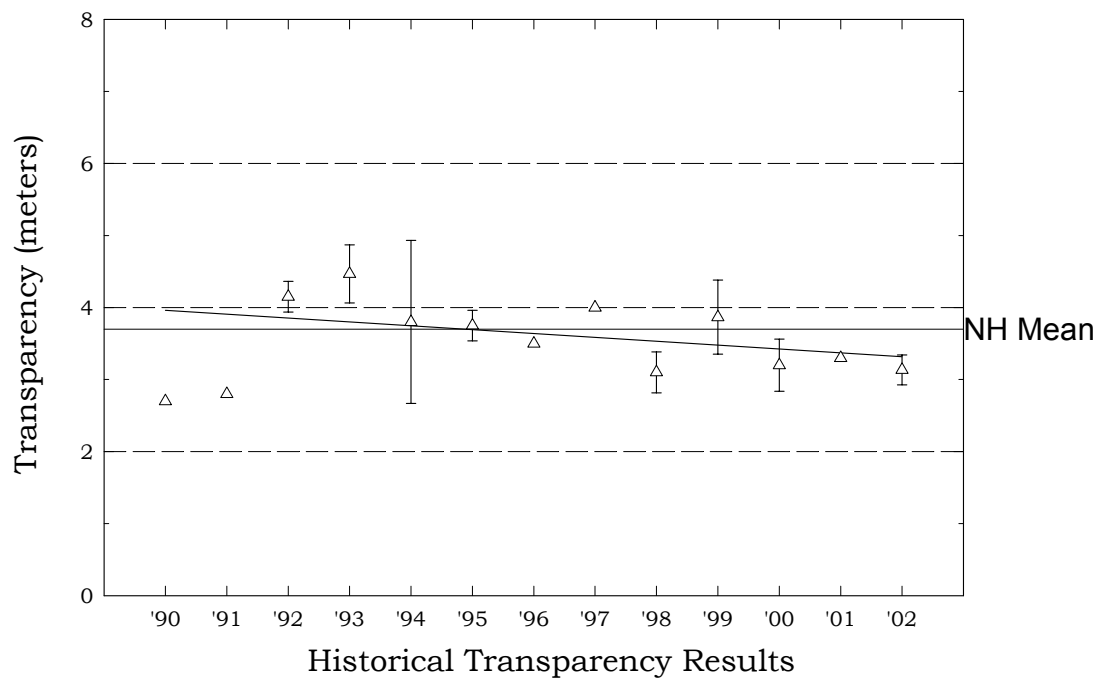
**Figure 2.** Monthly and Historical Transparency Results

- **Figure 2 and Table 3:** The graphs in Figure 2 (Appendix A) show historical and current year data for lake/pond transparency. Table 3 lists the maximum, minimum and mean transparency data for each sampling season that the lake/pond has been monitored through the program.

The current year data (the top graph) show that the in-lake transparency **increased slightly** from June to July, and then **increased slightly again** from July to September.

The historical data (the bottom graph) show that the 2002 mean transparency is **slightly less than** the state mean.

Overall, the statistical analysis of the historical data (the bottom graph) show that the mean annual in-lake transparency has **not significantly changed** (either *increased* or *decreased*) since monitoring began in **1990**. Specifically, the in-lake transparency has remained **relatively stable**, ranging between approximately **3** and **4** meters. (Note: Please refer to Appendix E for the statistical analysis explanation and data print out.)

Typically, high intensity rainfall causes erosion of sediments into lakes/ponds and streams, thus decreasing clarity. Efforts should continually be made to stabilize stream banks, lake/pond shorelines, disturbed soils within the watershed, and especially dirt roads located immediately adjacent to the edge of tributaries and the lake/pond. Guides to Best Management Practices designed to reduce, and possibly even eliminate, nonpoint source pollutants, such as sediment loading, are available from NHDES upon request.

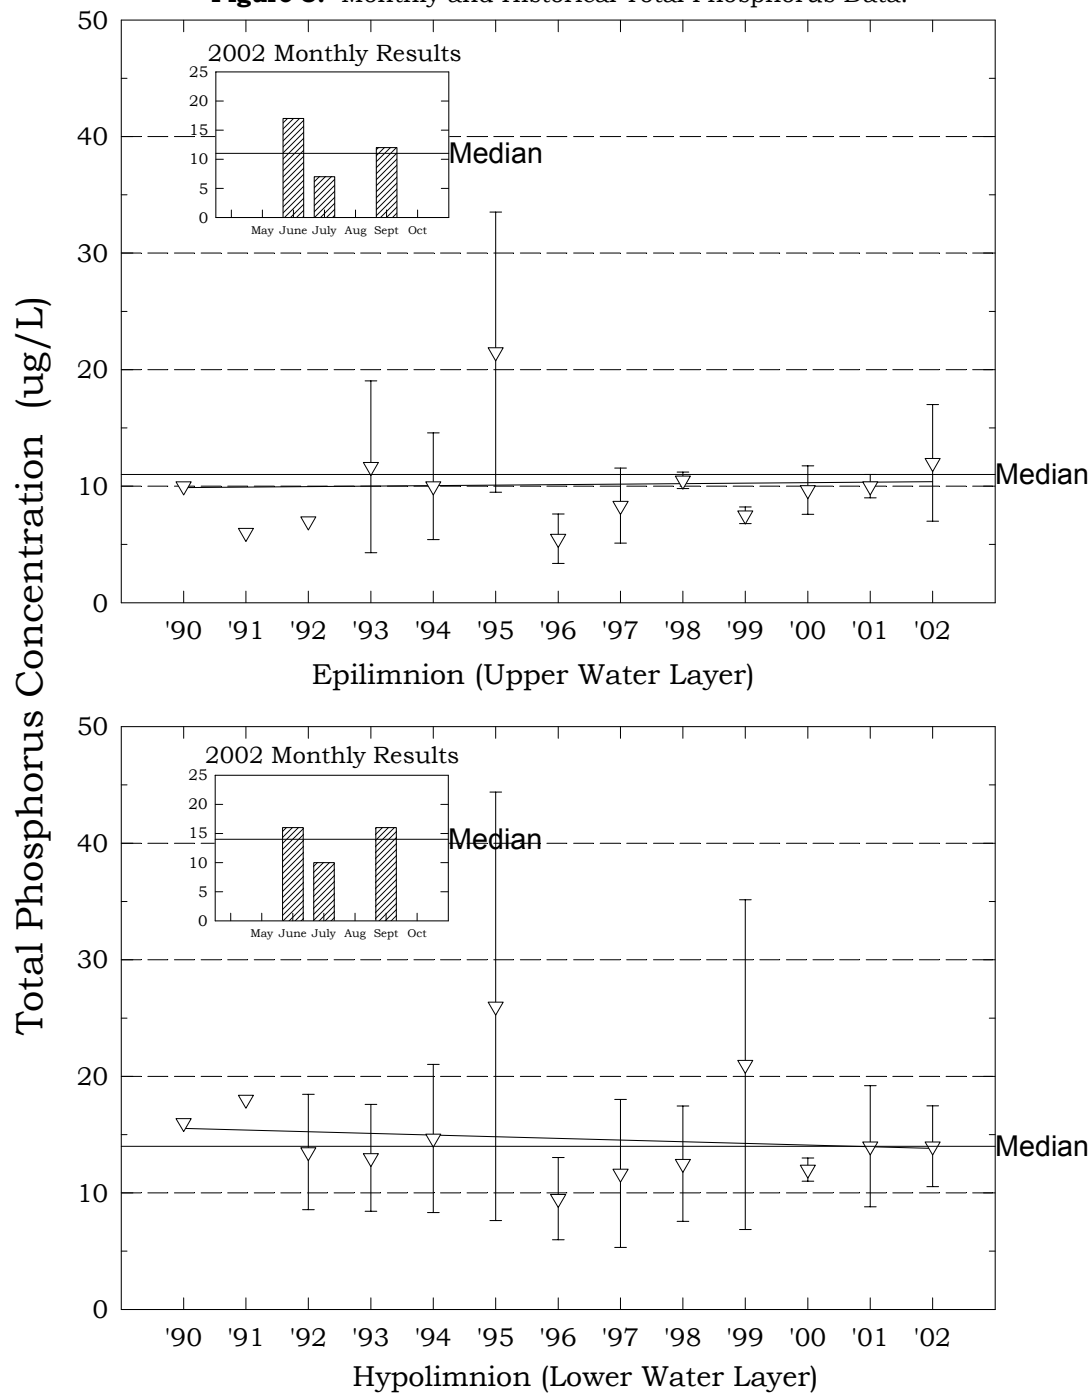
**Figure 3.** Monthly and Historical Total Phosphorus Data.

- **Figure 3 and Table 8:** The graphs in Figure 3 (Appendix A) show the amounts of phosphorus in the epilimnion (the upper layer) and the hypolimnion (the lower layer); the inset graphs show current year data. Table 8 (Appendix B) lists the annual maximum, minimum, and median concentration for each deep spot layer and each tributary since the lake/pond has joined the program.

The current year data for the epilimnion (the top inset graph) show that the total phosphorus concentration in the epilimnion and hypolimnion **decreased greatly** from June to July, and then

**increased** from July to September. The total phosphorus concentration in June and September for both layers was **greater than** the state median.

The historical data show that the 2002 mean total phosphorus concentration for the epilimnion and hypolimnion is **approximately equal to** the state median.

Overall, the statistical analysis of the historical data show that the total phosphorus concentration in the epilimnion (upper layer) and the hypolimnion (lower layer) has **not significantly changed** (either *increased* or *decreased*) since monitoring began in **1990**. Specifically, the total phosphorus concentration in the epilimnion and hypolimnion has **varied** (meaning **fluctuated**), but has not *continually increased* or *decreased* since monitoring began. (Note: Please refer to Appendix E for the statistical analysis explanation and data print out.)

One of the most important approaches to reducing phosphorus loading to a waterbody is to continually educate watershed residents about its sources and how excessive amounts can adversely impact the ecology and value of lakes and ponds. Phosphorus sources within a lake or pond's watershed typically include septic systems, animal waste, lawn fertilizer, road and construction erosion, and natural wetlands. If you would like to educate watershed residents about how they can help to reduce phosphorus loading into the lake/pond, please contact the VLAP Coordinator.
